Castle Rock
Reservoir Dams,
Rosebud County,
Montana, Main Dam,
MT-1982, Saddle
Dam, MT-3146

**INSPECTION REPORT
NATIONAL DAM SAFETY PROGRAM**

**Christian, Spring, Sielbach & Associates
Bozeman, Montana**

June 1981

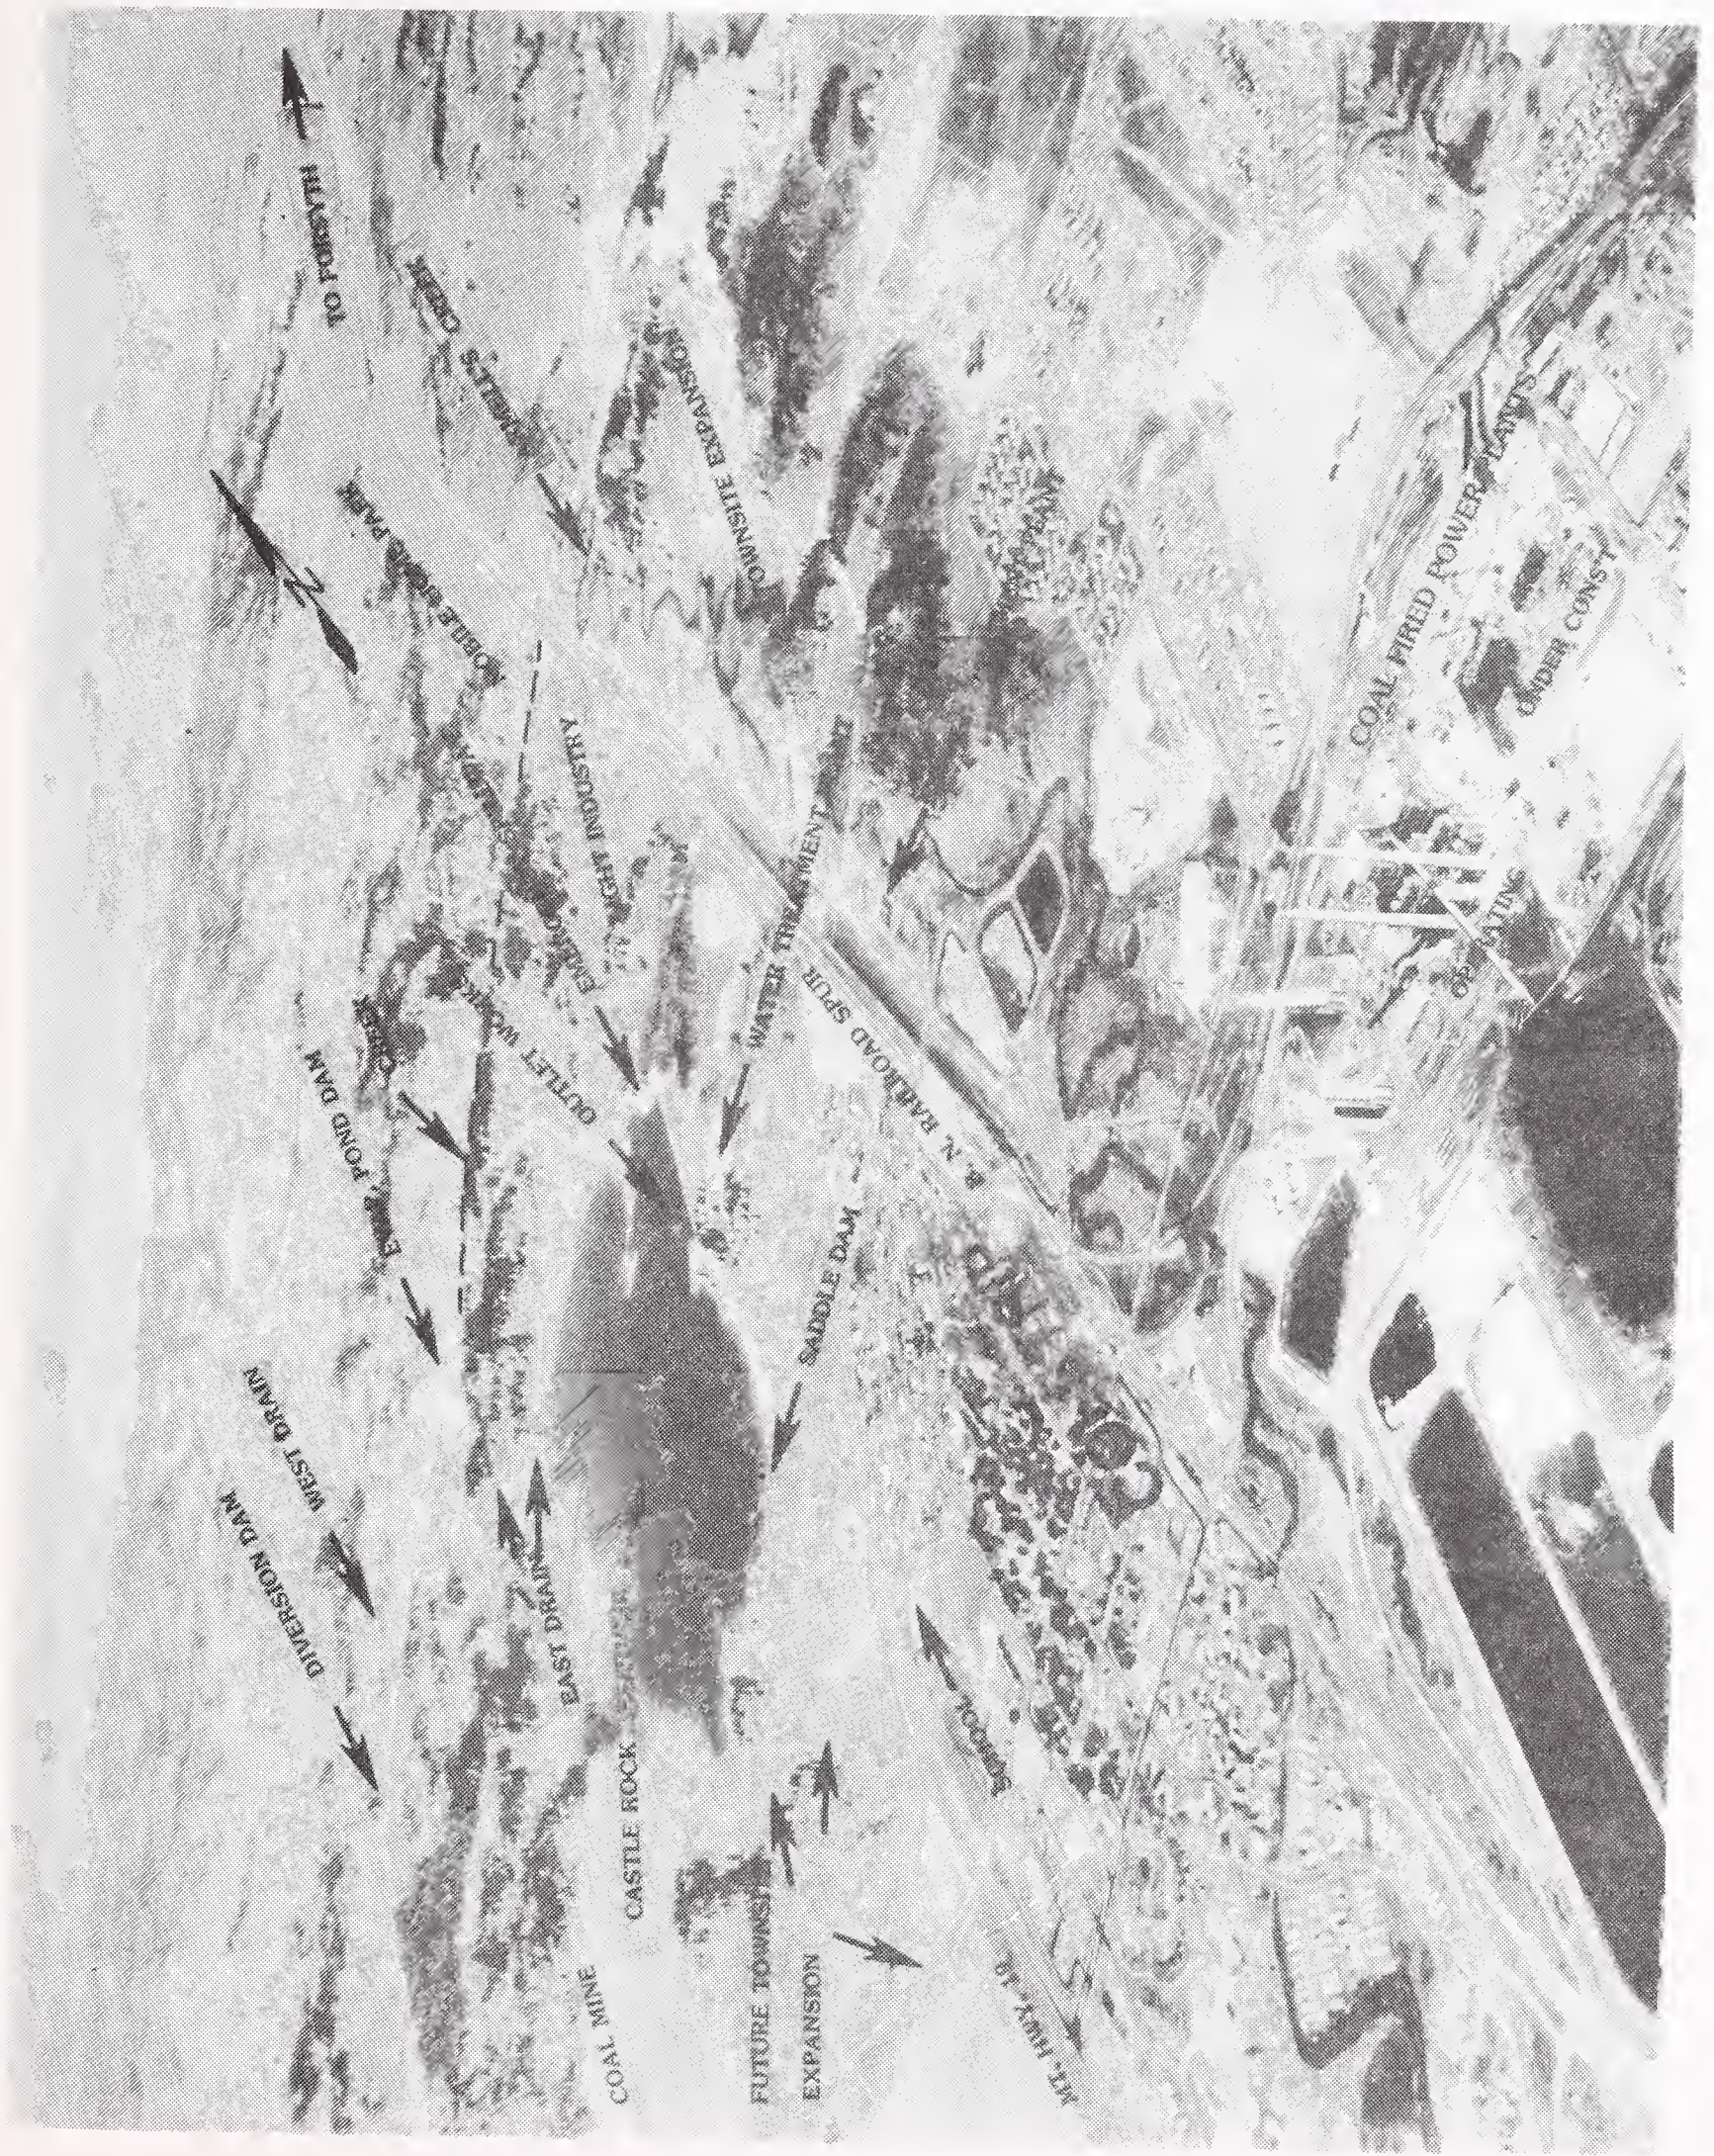
PHOTO 1
Spillway Outlet
(Note erosion potential)

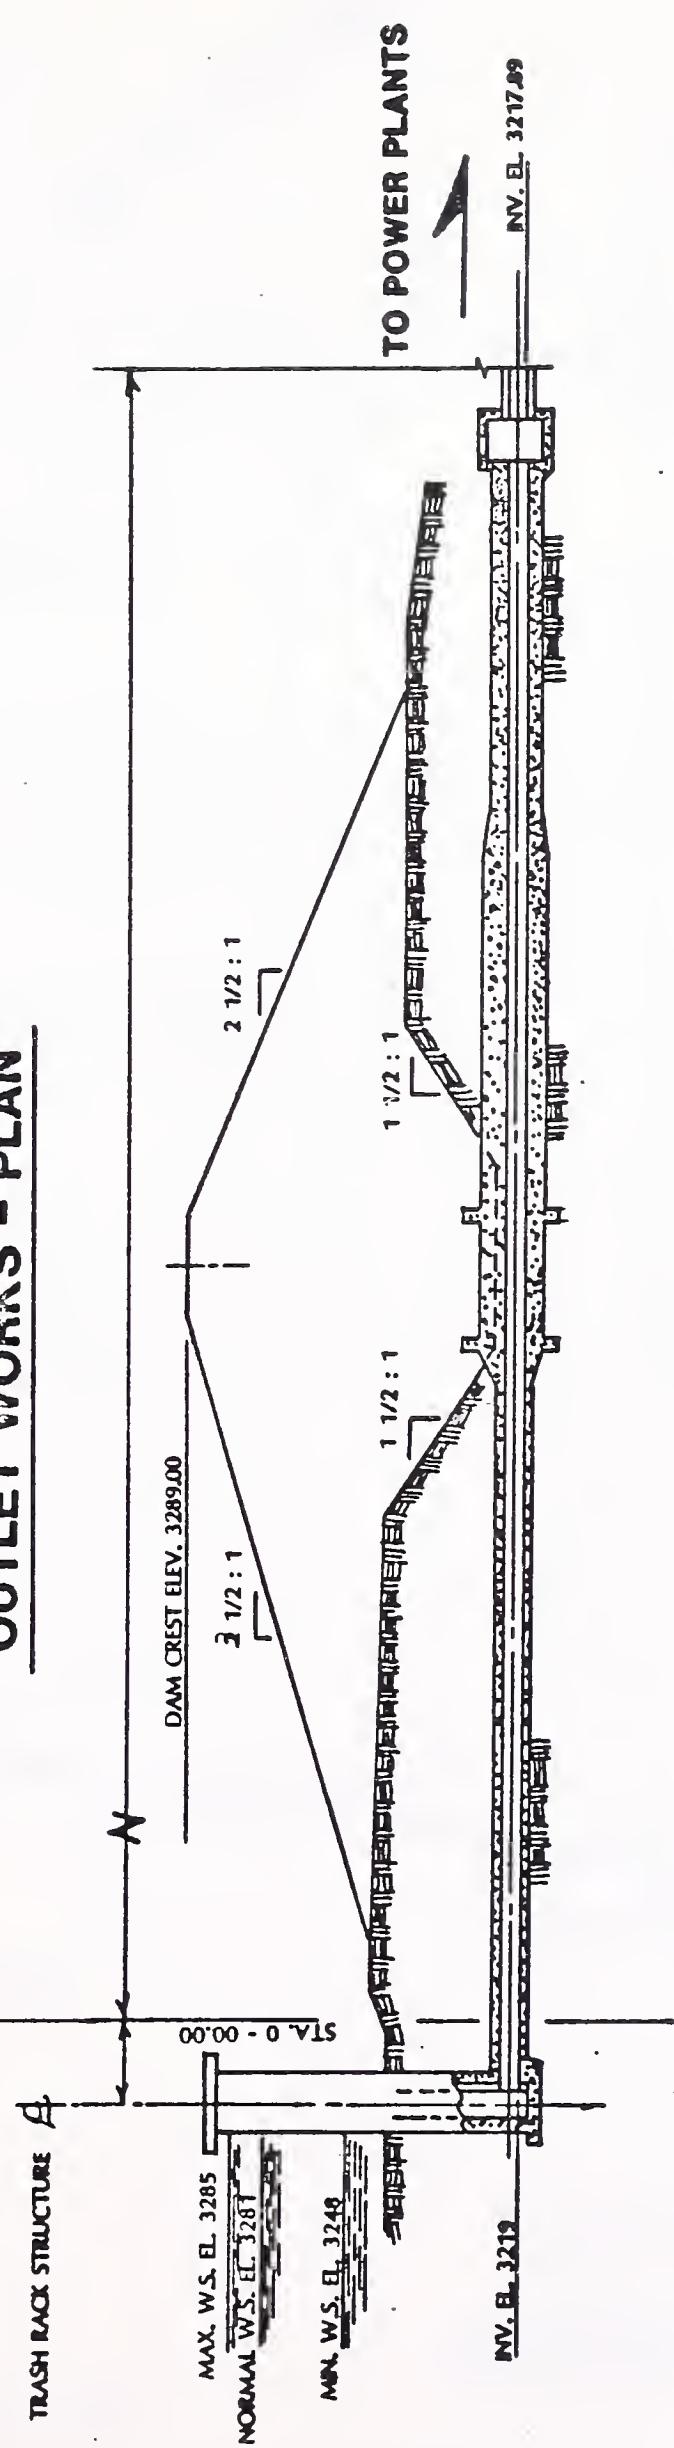
PLATE -8-
CASTLE ROCK DAM
OUTLET WORKS

The inlet structure for the outlet works for Castle Rock Reservoir is an 80 foot tall, 13 foot square concrete tower. (Plate 8) The 6 foot by 40 foot trash racks on three sides, from elevation 3240 feet to 3280 feet, allow flows to enter the hollow core of the structure. Discharge is through a 48-inch diameter welded steel pipe. This pipe is encased in concrete for the first 160 feet to the cutoff trench of the main dam embankment. From there it is installed as a free standing pipe in an 8-foot diameter concrete culvert. The outlet conduit is set about seven feet into bedrock near the right abutment. Flows are piped directly into the power plant's cooling network and the City of Colstrip's water treatment plant. Water levels at the time of inspection prohibited inspection of the outlet works.

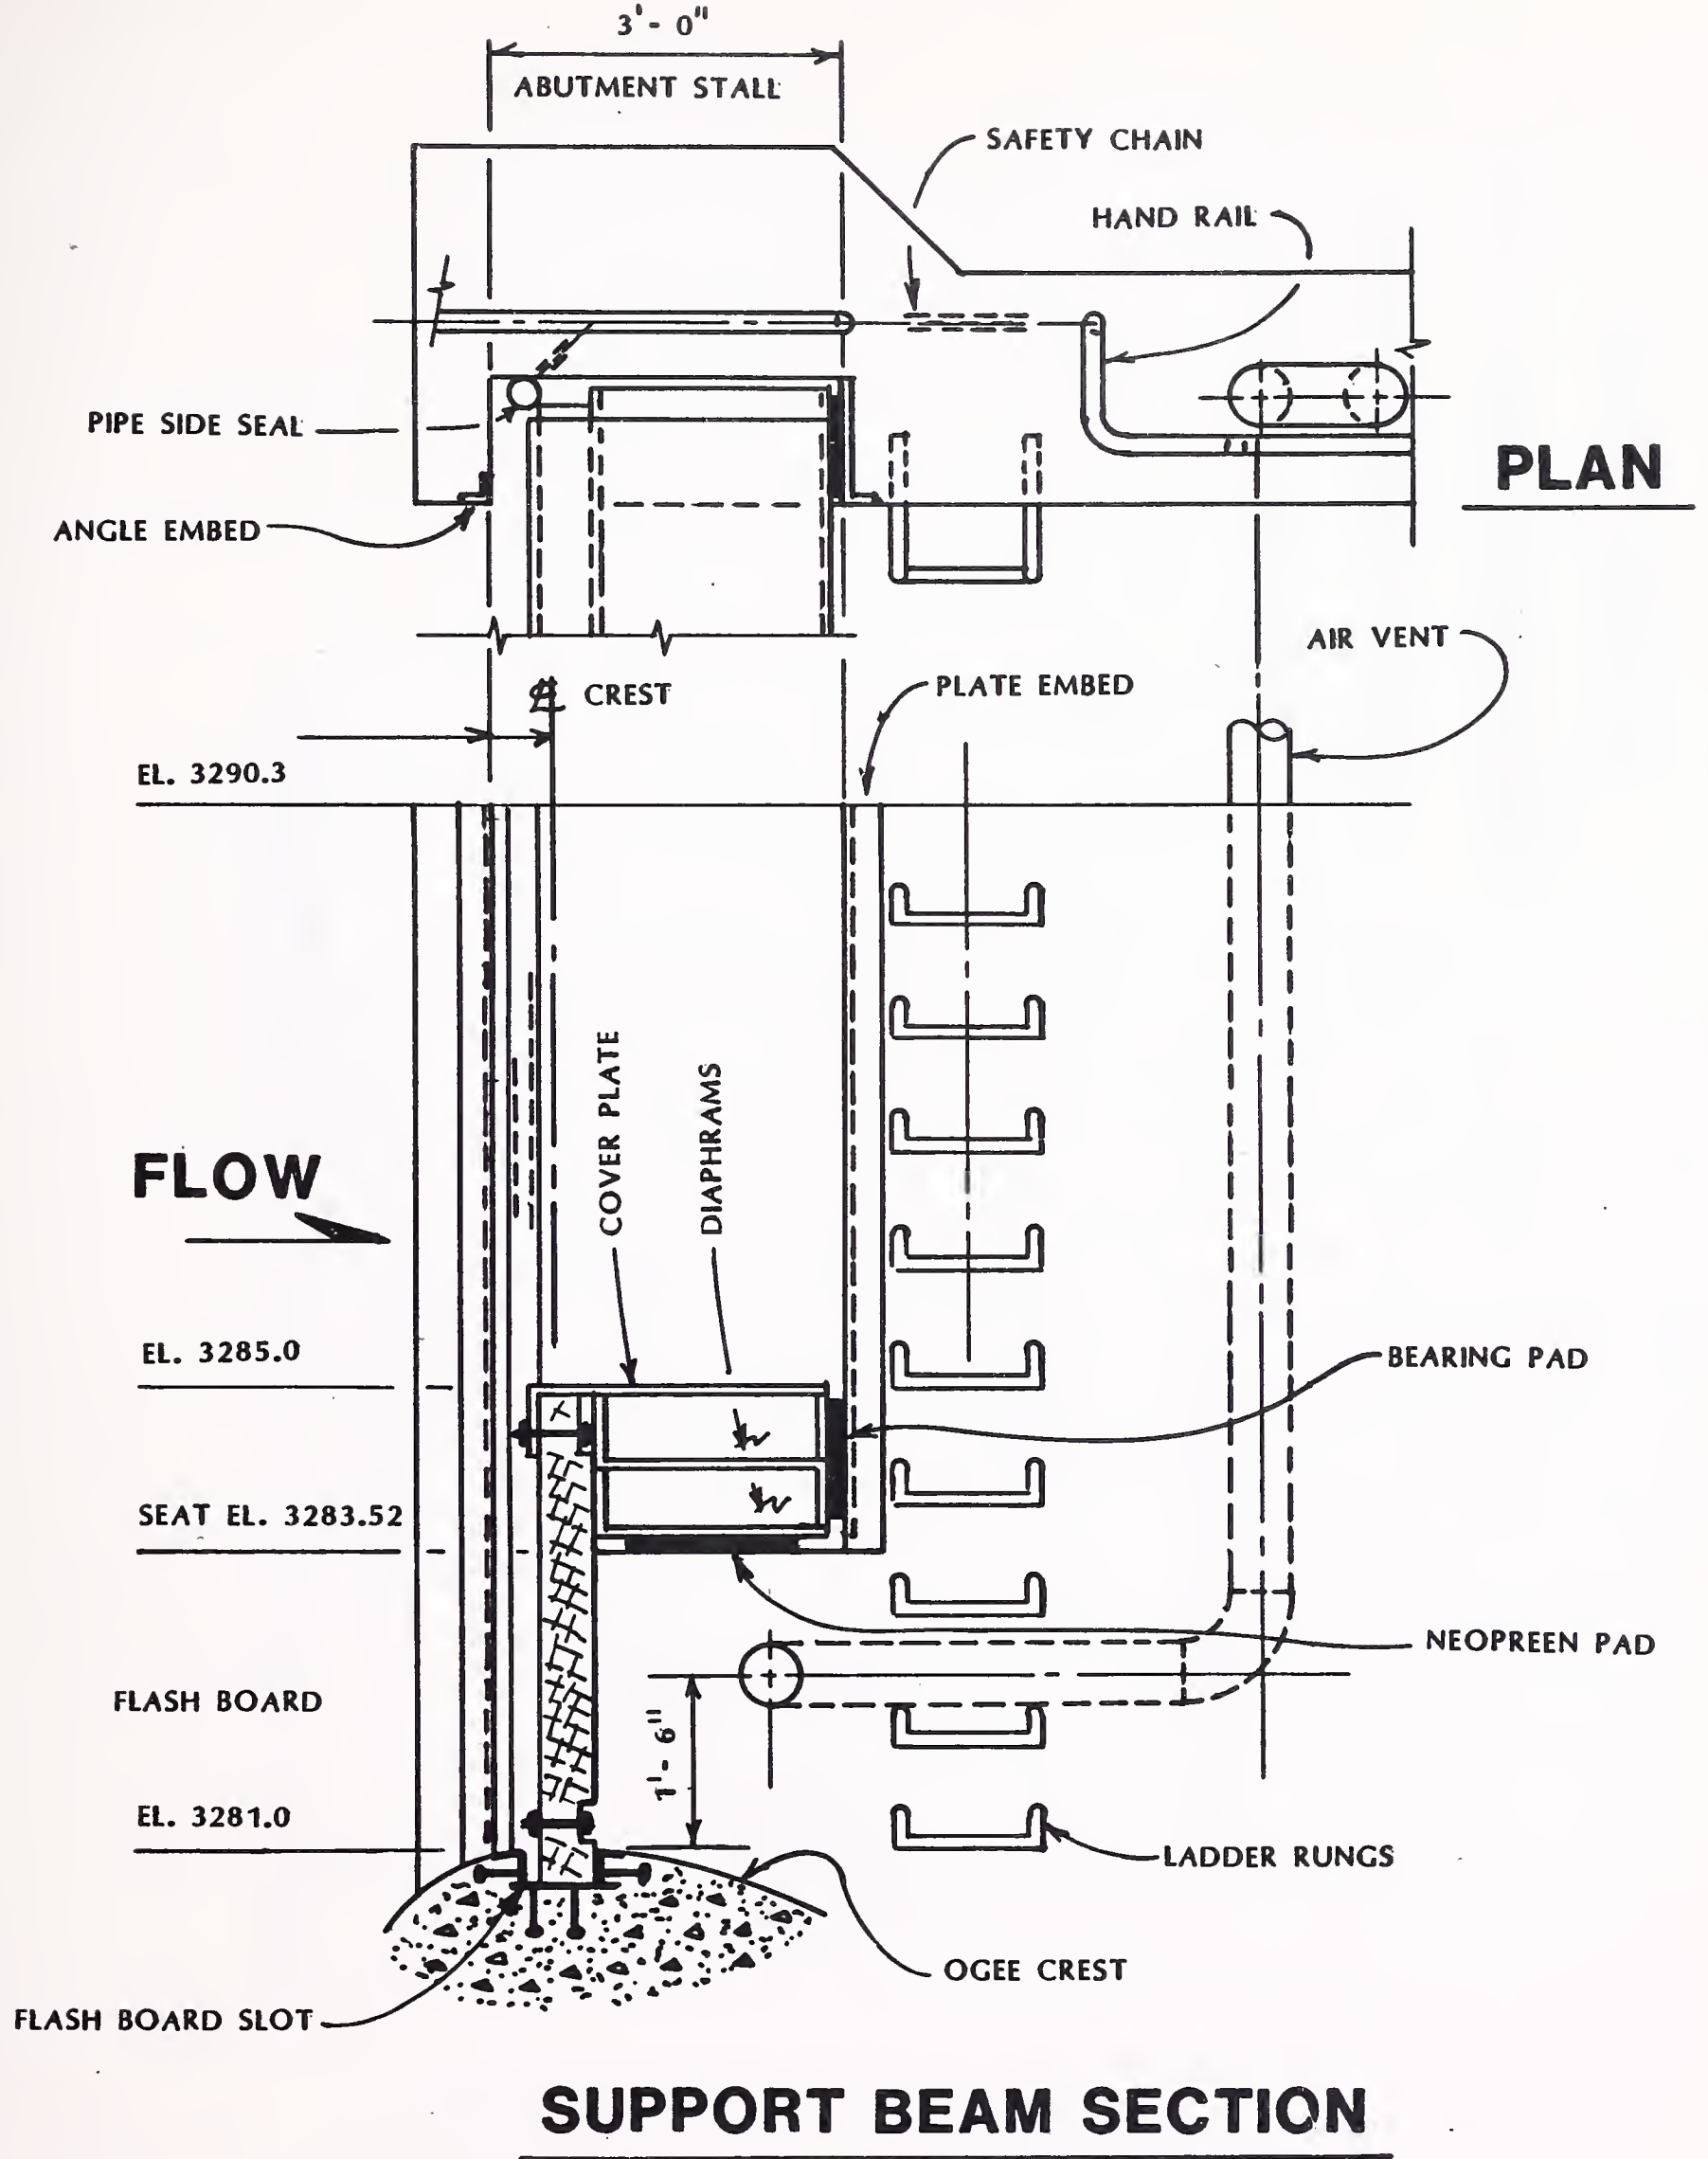
PLATE -10-

The emergency spillway for the Castle Rock Reservoir dams is a reinforced concrete chute located on the left abutment approximately 200 feet north-west of the north end of the Main dam. (Plate 9) The entrance to the spillway is an uncontrolled ogee section with a crest length of 36 feet. Sidewall height at the ogee crest is 9 feet. The spillway terminates in a flip bucket with the end sill at an elevation well above the bottom of the excavated stilling basin energy dissipator. (Photo 1) Provisions have been made to install flash boards at the spillway entrance to increase storage in winter months. (Plate 10) The flashboards were in place at the time of the field inspection. (Photo 2)
